# Manhole Inspection Summary

Manhole # S19MM\_021MH

Insp Date: **7/3/07 10:55 AM**

**Location** Address: **2001 WINDSOR AVE**

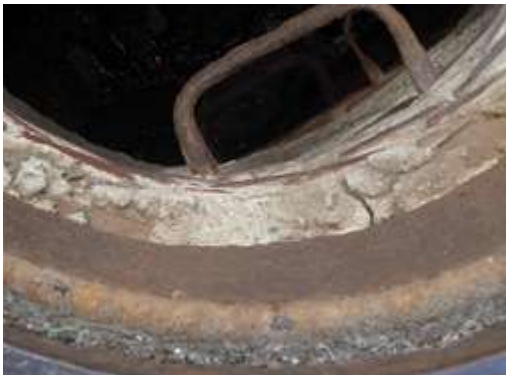
Defect 2

Offset: **2** (in.)

FRAME OFFSET

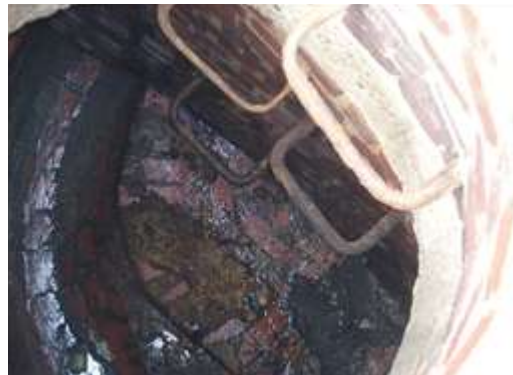
Defect 1

Count: **4** Missing: **0** ☒ **Corroded**

CORRODED STEPS

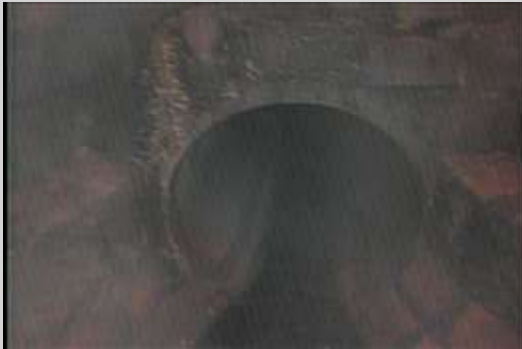
12 O'Clock Outflow

10 in. Circular Gravity Sewer  
Pipe Out @ 12 O'Clock

Pipe Height: **10.8** (in.) Rod and Bar (Angled)  
Pipe Material: **Clay** ☐ Pipe Lined  
Invert Depth: **9.83** (ft.) Flow Characteristics: **Slow**  
Deposits: ☒ None ☐ Mud ☐ Sludge ☐ Debris ☐ Grease  
Silt Depth: (in.) Deposits Extent:  
Infiltration: **None** Pipe Seal Cond: **Sound**

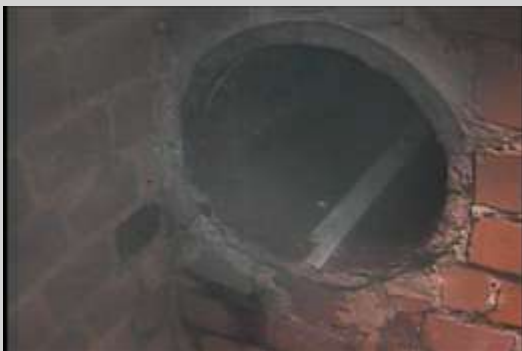
6 O'Clock Inflow

FRAME OFFSET

Pipe Height: **9.6** (in.) Rod and Bar (Angled)  
Pipe Material: **Clay** ☐ Pipe Lined  
Invert Depth: **5.31** (ft.) Flow Characteristics: **Slow**  
Deposits: ☒ None ☐ Mud ☐ Sludge ☐ Debris ☐ Grease  
Silt Depth: (in.) Deposits Extent:  
Infiltration: **None** Pipe Seal Cond: **Sound**

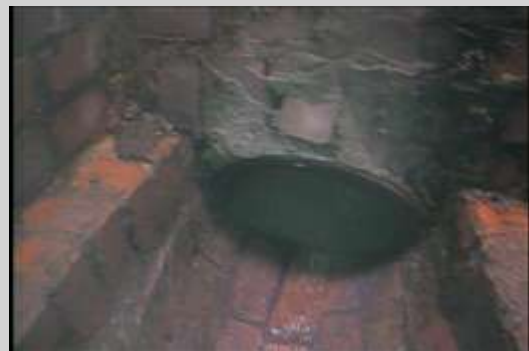
Drop In @ 6 O'Clock

FRAME OFFSET

Drop: **Outside** Rod and Bar  
Angled: **Yes** Reading: **7.58** (ft.)  
Inv Depth: **8.58** (ft.)

Drop Condition: **Open**

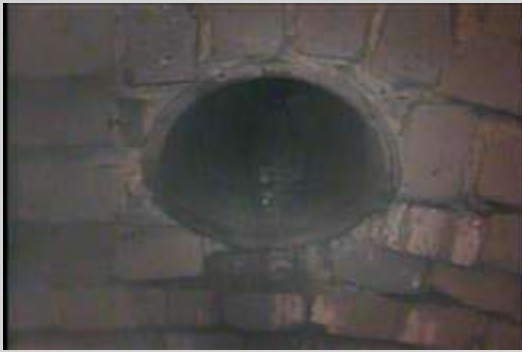
9 O'Clock Inflow

Pipe Height: **8.4** (in.) Rod and Bar (Angled)

Pipe Material: **Clay** ☐ Pipe Lined

Invert Depth: **5.28** (ft.) Flow Characteristics: **Slow**

Infiltration: **None** Pipe Seal Cond: **Sound**

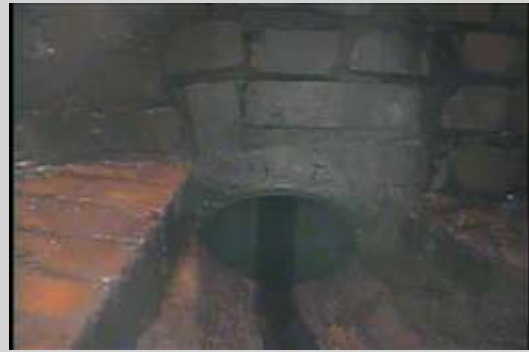
Drop In @ 9 O'Clock

Drop: **Outside** Rod and Bar

Angled: **Yes** Reading: **8.07** (ft.)

Inv Depth: **9.07** (ft.)

Drop Condition: **Open**
